Keel report 2025

NSA – KEEL REPORT 2025

In Norway, there have been two incidents involving the lifting of a Soling using the centre lift. Fortunately, neither of these incidents resulted to human injuries. The incident with NOR 103 resulted in severe damage to the boat.

The Norwegian Soling Association, NSA decided to establish a Working Group (WG) to investigate the NOR 103 incident. The primary goals of this group are to understand the root cause for the incident, identify lessons learned, and share the information within the Soling community. The Soling fleet is aging, and it is likely that boats will require preventive maintenance to ensure that similar incidents do not occur in the future.

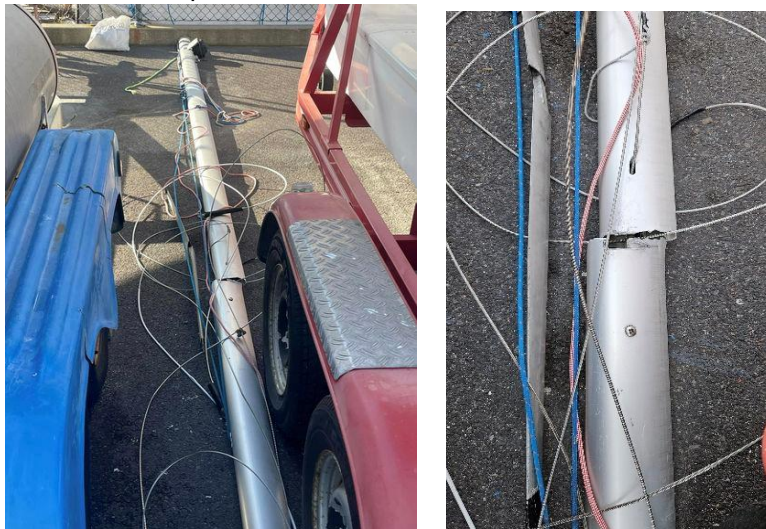
- The fore and aft stays, as well as the upper and lower shrouds, were not broken in the incident (see pic 3).
- The mast was removed from the boat, and it was confirmed that the mast was broken in two at the point of the spreaders.

Pic 3 & 3b: Mast broken at the spreaders.

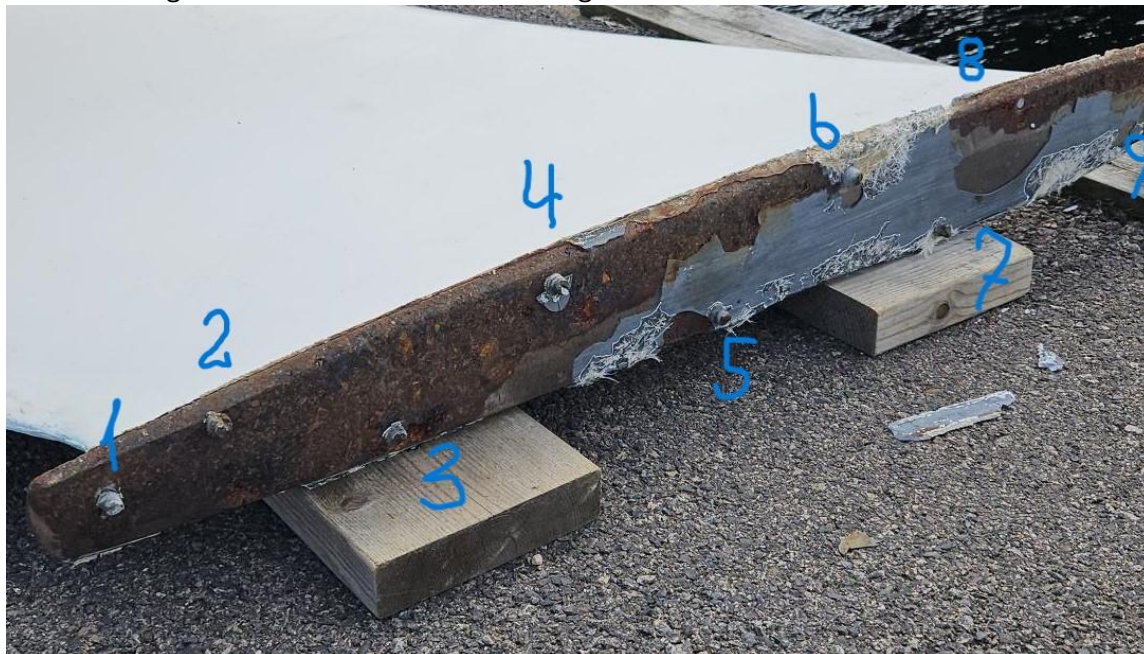
- Since the boat was lying on its port side, a twisting force from the keel to the hull was created.
- When the new lifting started, the keel separated from the hull and fell onto the quay (see pics 4a & 4b)

Pic 4a: Keel and numbering of the bolts. Approximately 80% of the top of the keel is corroded and 20% with glue which also had some holding function of the keel.

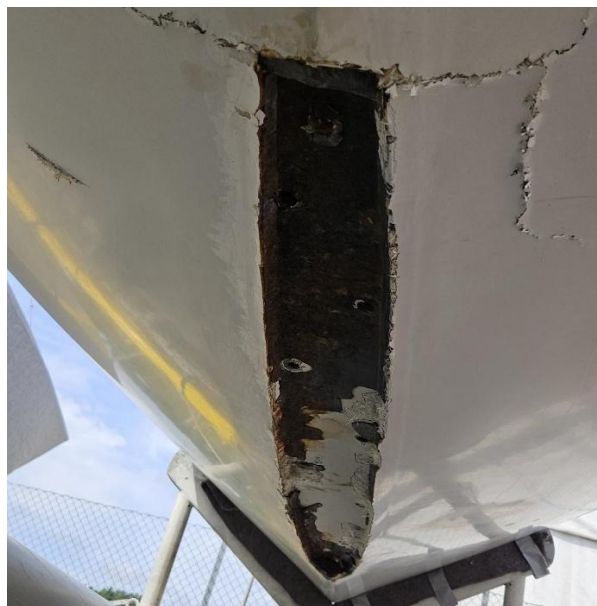
Pic 4b: Keel case and cracks in the hull after the boat was stored in the trailer.

Comment: The cracks on the sides aft of the keel cannot be seen on pic 1. The cracks were made at the 2nd lifting of the boat. This also complies with how one of the crew remember the 2nd lift.

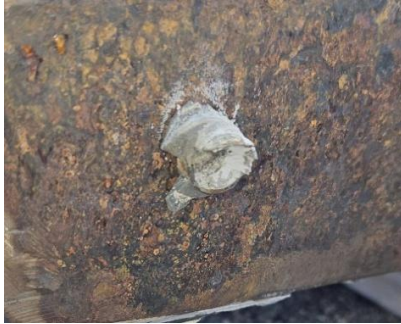
Pic 5a: Bolt #1, rear used for lifting.

Comment: Bolt is corroded around keel. Some glue on bolt to the hull. A groove on top which was the remaining strength of the bolt.

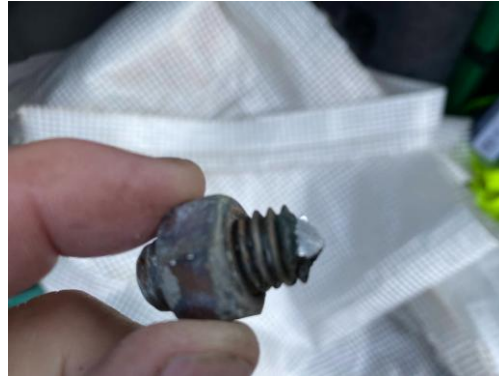
Pic 5b Bolt #1: Comment: A fresh cut shows the remaining strength of the bolt.

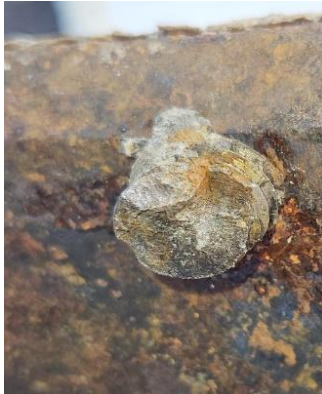
Pic 6: Bolt # 2, Comment: Bolt strongly corroded for some time. Broken and no holding function.

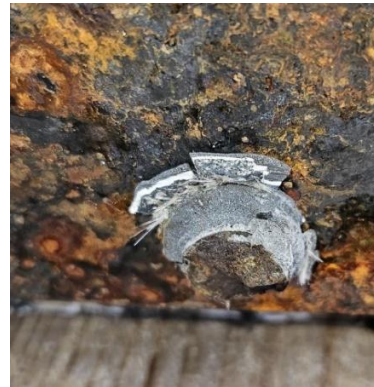
Pic 7: Bolt # 3. Comment: Bolt strongly corroded for some time. Broken and no holding function. Some 'glue' left around the bolt in 'hull hole'.

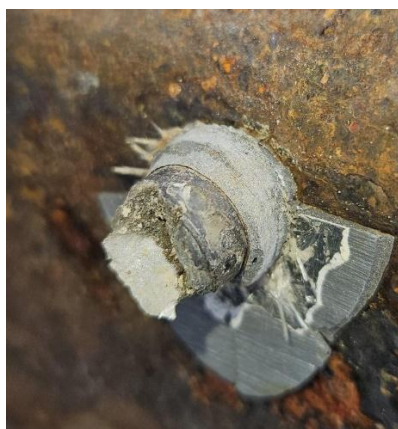
Pic 8a: Bolt #4 (used for lifting)

- There were long cracks between the keel and hull on both sides that had not been sealed. These cracks had been present for a long time and exposed the keel to salty water.
- Both lifting bolts were modified, as seen in picture 8a, with a shackle and fibre sling. The lifting wires were removed.
- In recent years, the boat was always lifted using the modified centre lift.
- There was about 100 litres of water in the keel before lifting. The plan was to drain the water once the boat was in the sea.

Comment: Bolt corroded in the area of hull, washer and nut. **The incident started when this bolt snapped.**

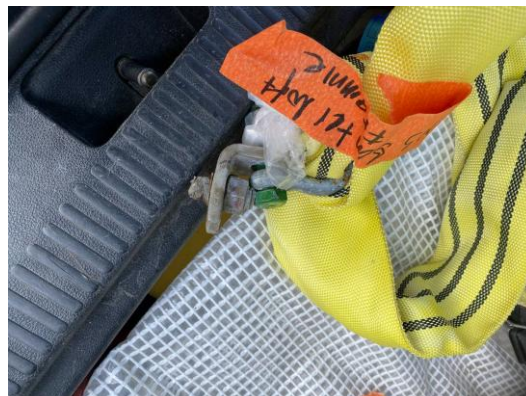
Pic 8b: Bolt # 4. Comment: Modified shackle and fiber sling replacing the original wire.

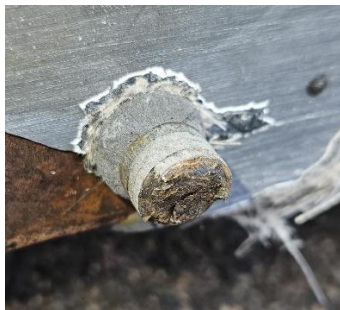
Pic 9: Bolt #5. Comment: Bolt strongly corroded for some time in the area hull, washer and nut. No holding function. Glue around the bolt and on keel.

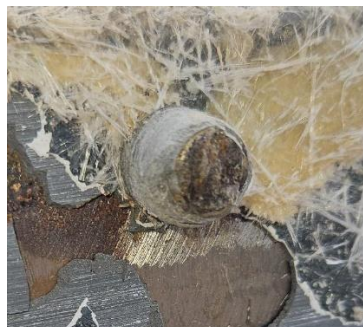
Pic 10: Bolt #6. Comment: Bolt strongly corroded for some time in the area hull, washer and nut. No holding function. Glue around the bolt and on keel.

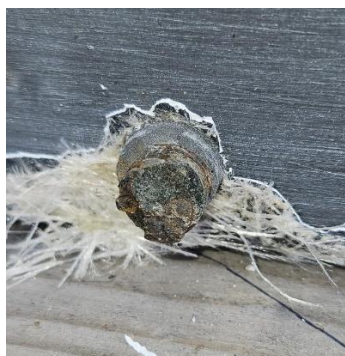
Pic 11: Bolt #7. Comment: Bolt strongly corroded for some time in the area hull, washer and nut. No holding function. Glue around the bolt and on keel. Very little, if any holding function in the glue.

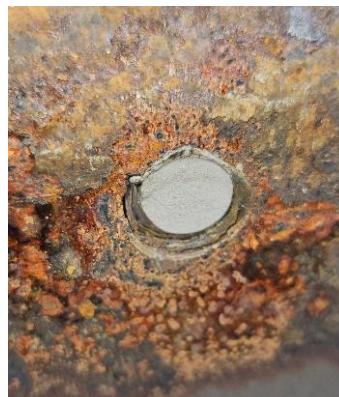
Bolt #8 seems to be a bolt with low corrosion. This bolt most likely broke when the boat was lifted for the second time while lying on the quay. The load of the keel was transferred to bolt #8 during lifting and the remaining glue around bolt #5, 6,7 and 9. All other bolts are corroded and broken area around the hull, washer, and nut.

Pic 12: Bolt # 8. Comment: Some corrosion of the outer part(ring) of the bolt. The 'clean' surface indicates the bolt snapped at second lifting of the boat.

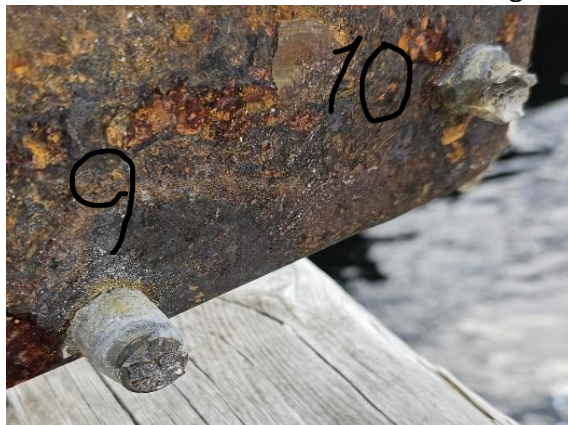
Pic 13: Bolt # 9 & 10 (at front). Comment: Bolts have been strongly corroded for some time. Bolt #9 is corroded in the area hull, washer and nut. Maybe some holding function. Bolt #10 is corroded in the area between keel and bolt. No holding function in bolt.

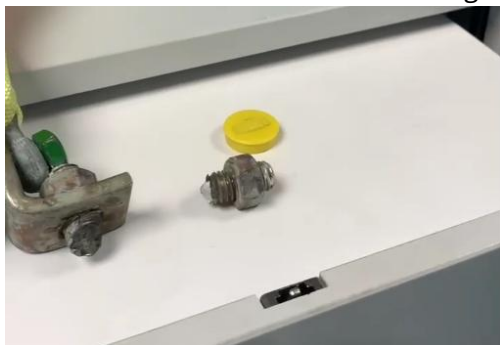
Pic 14; Magnetic test of Bolt #1 and Bolt #4 (with shackle)

Comment: The shackle and bolts are magnetic

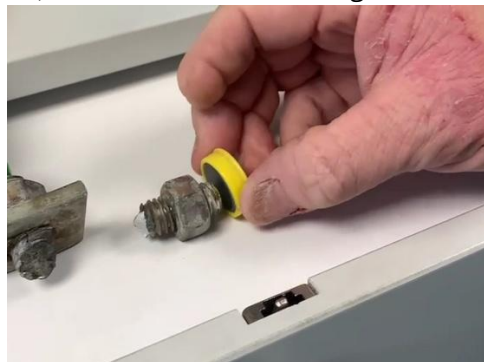
Pic 15; Comment: The magneto test of bolt #1, bolt connects to the magneto

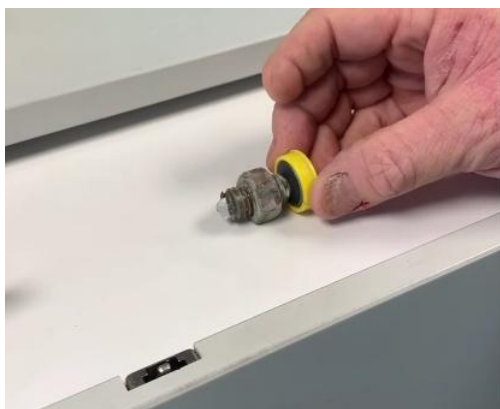
Pic 16; Comment: The bolt #1 connects to the magneto and could be hauled over the table.

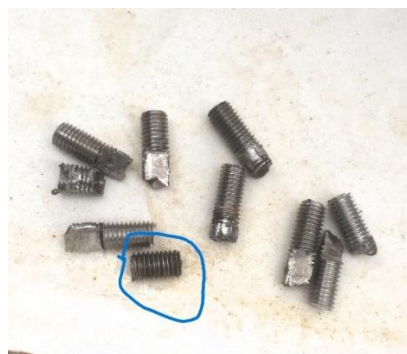
In the area at the top of the keel, hull, and bolt, the keel has the lowest corrosion potential and acts as the sacrificial anode. As seen on NOR 103 and in Pic 17, the threads of the bolt that are screwed into the keel have their original shape and diameter as if the bolts were new.

Pic 17; All 10 bolts removed from keel.
Comment: The bottom part of all bolts, which are in the keel have treads as they were 'new'.
Bolt with ring is most likely the bolt #8.

- Why the bolts are magnetic
- The keel is the sacrificing anode compared to the bolt. We see good treads, pic 17
- The bolts are sacrificing anode compared to nut and washer, which are better quality and not magnetic.

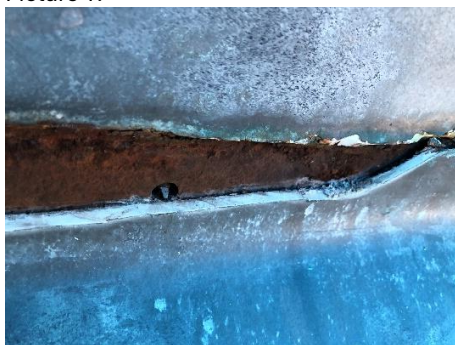
Picture 1:

Long cracks between the keel and hull on both sides had been there for a long time and corrosion had developed over many years on the keel, ref picture 1.

A long crack along the keel-hull and with a lot of rust on the keel. One the bolt in the hole is corroded or made like this?

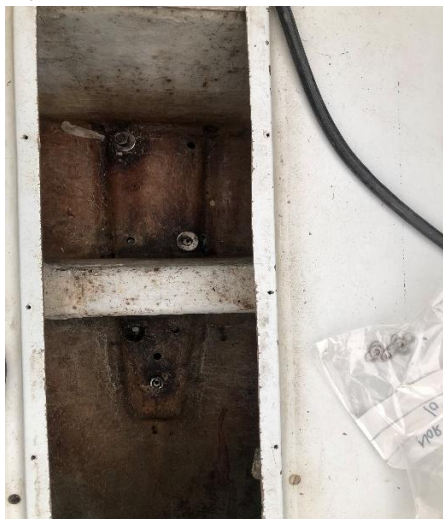
Pic 2:

5 keel bolts were damaged and had to be renewed, ref picture 2.

Hull had dark colour
Bolts 1-4 heavy corroded.

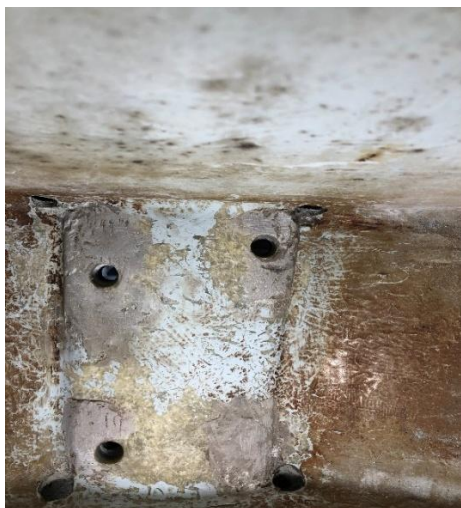
One observation, ref III. The hull areas around the bolts are not flat. The part facing towards the centreline is higher and causes higher pressure from the nut on the washer/hull than on the part facing away from the centre line of the boat.

III: For bolts that had to be renewed a new bolt was inserted on opposite site to the other. The foundation area under each bolt were made flatter by sanding away the Geal Coat and adding GRP spackle.

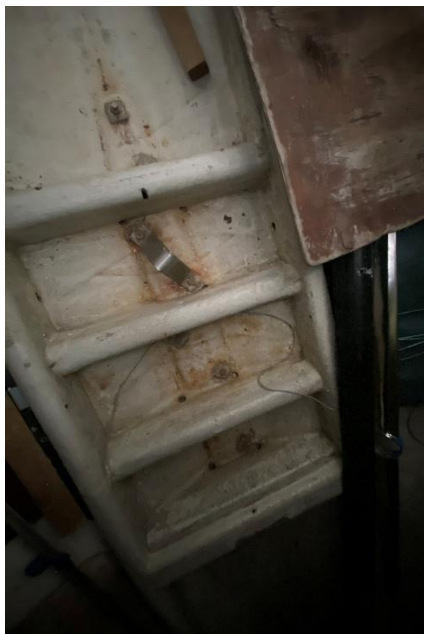
Pic1 Keel inside, centre lift using a hoop on bolt 3 and 4.

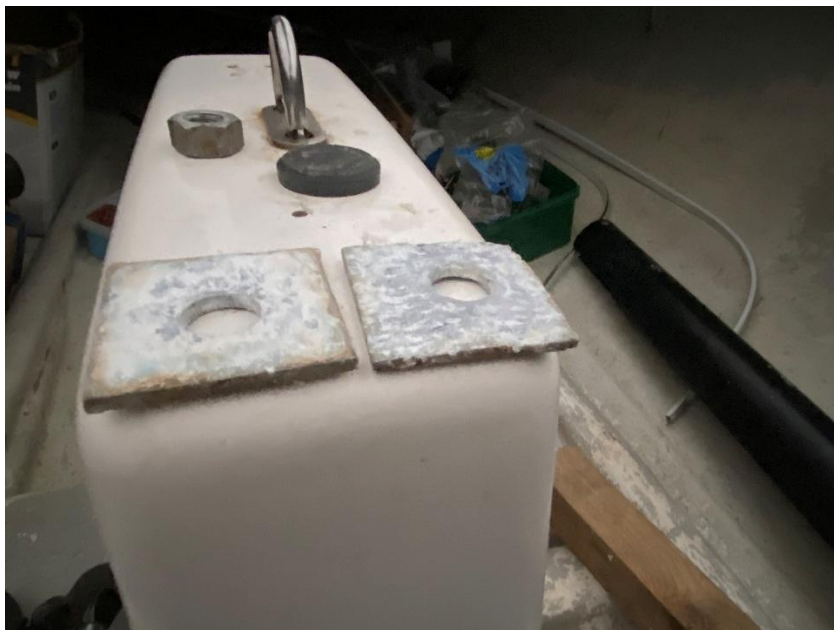
Observation. The bolts and nut are not magnetic. Some washers were made of aluminium. As can be seen on pic2 the washers are corroded.

Pic2, washers used is aluminium and corroded.

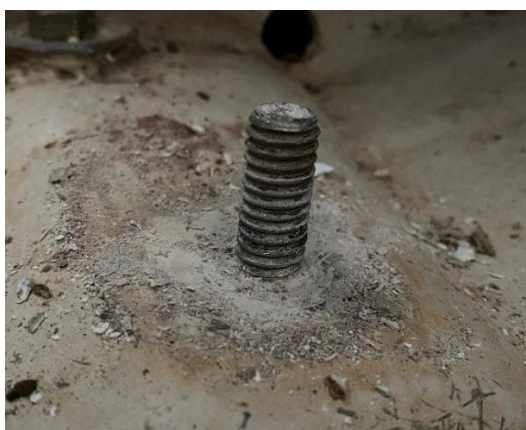
Pic3, bolt #2. Condition of treads seems to be ok, 55 years old. The condition of the bolt is not checked in detail.
