Keel report 2025

NSA – KEEL REPORT 2025

In Norway, there have been two incidents involving the lifting of a Soling using the centre lift. Fortunately, neither of these incidents resulted to human injuries. The incident with NOR 103 resulted in severe damage to the boat.

The Norwegian Soling Association, NSA decided to establish a Working Group (WG) to investigate the NOR 103 incident. The primary goals of this group are to understand the root cause for the incident, identify lessons learned, and share the information within the Soling community. The Soling fleet is aging, and it is likely that boats will require preventive maintenance to ensure that similar incidents do not occur in the future.

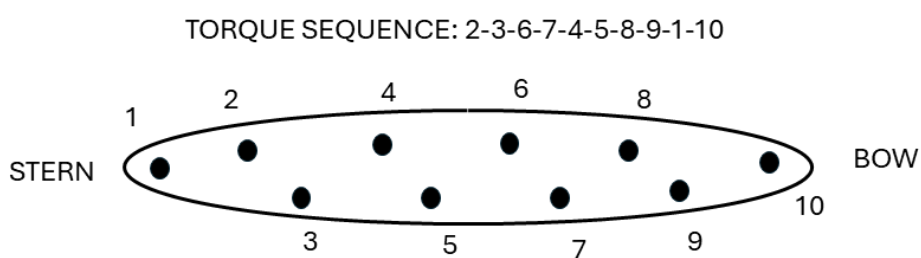
- The work procedure is to manually tighten the bolt. Use standard wrench and tighten as tight as much as you can without the use of extenders or other special tools. Then use a tightening torque to read the torque value by starting with a low number and increase until you find the number obtained by the manual tightening. Repeat the same for the remaining bolts and note the torque figure for each of the bolts. Those notes can be used as a basis for comparison for future maintenance and bolt re-tightening.
- Suggested sequence for tighten the bolts:
